# PRESERVING GRAND CENTRAL: HISTORY IN THE REMAKING

By Arthur Schurr

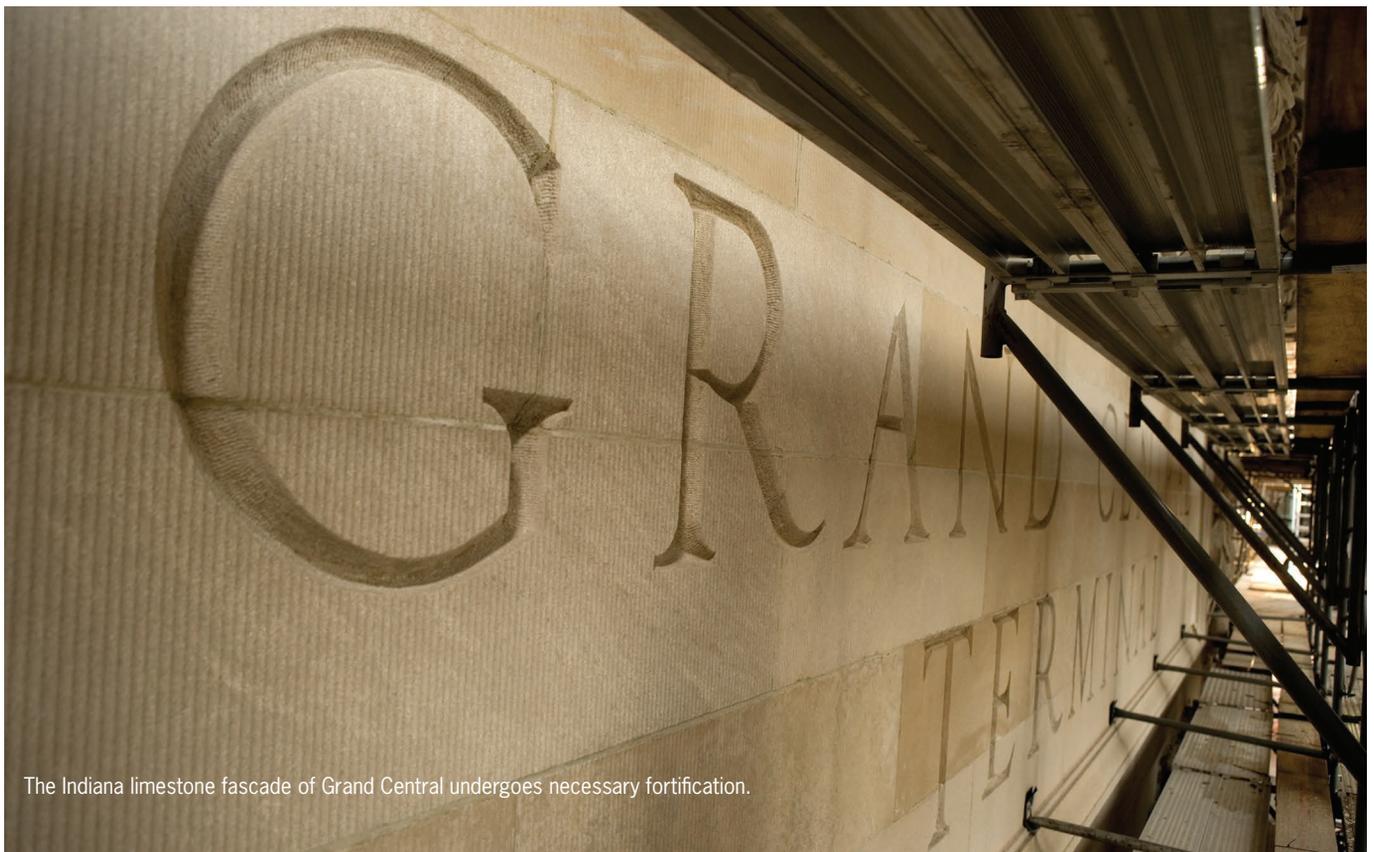
The Indiana limestone facade of Grand Central undergoes necessary fortification.

The Grand Central Terminal Existing Conditions Assessment Report serves a dual purpose, as a historical document and as a blueprint for renovation. With that document in hand, a renovation strategy was developed. Conducting lab tests to determine the best cleaning method, the project team also performed paint tests to match the original door and window paint. To restore moldings, a cement-lime polymer mixture was created to match the limestone. The complex mechanical system for opening and closing the enormous cast iron-encased windows is also being restored and made operable. And expansion joints are being installed in the stone
